Sage Dairy – Figure C E I V E D

Facility overview and prominent site features

DAIRY BUREAU

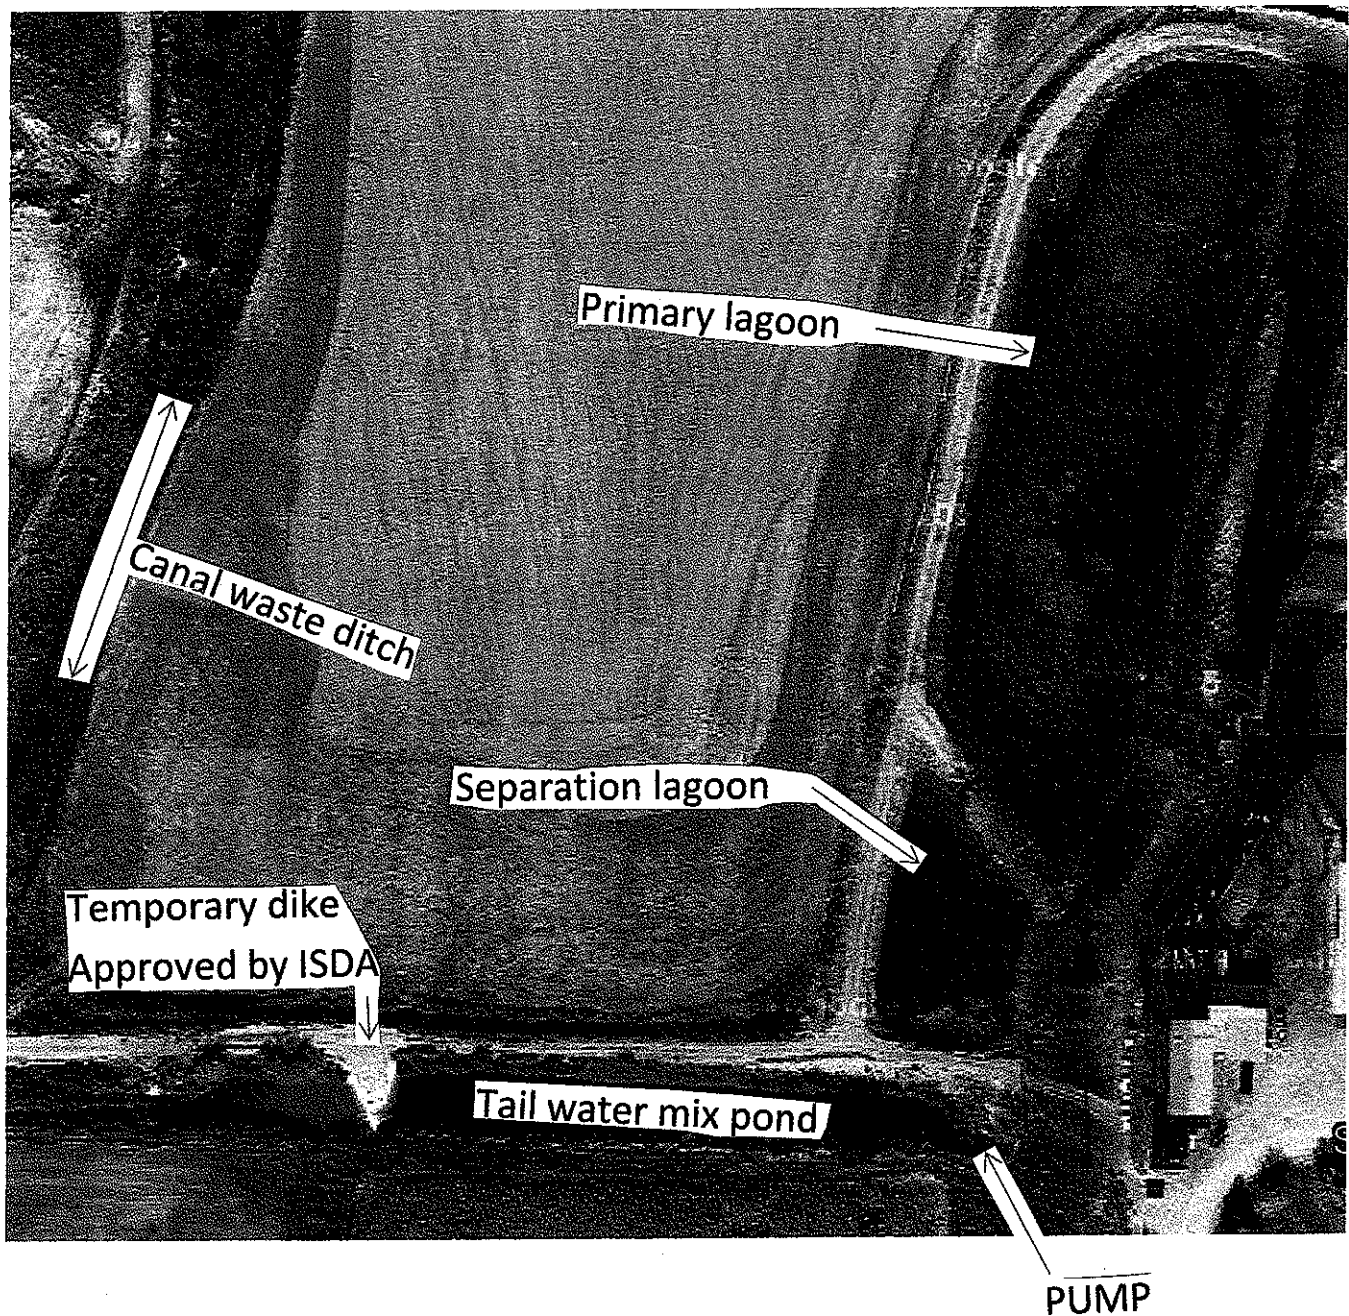
Irrigation canal
associated with
Black Canyon Dam

Sand Hollow Drainage – fed by
water from irrigation canal

Liquid waste
management ponds

NEW
DIVERSION

Continuation of
Sand Hollow
Drainage

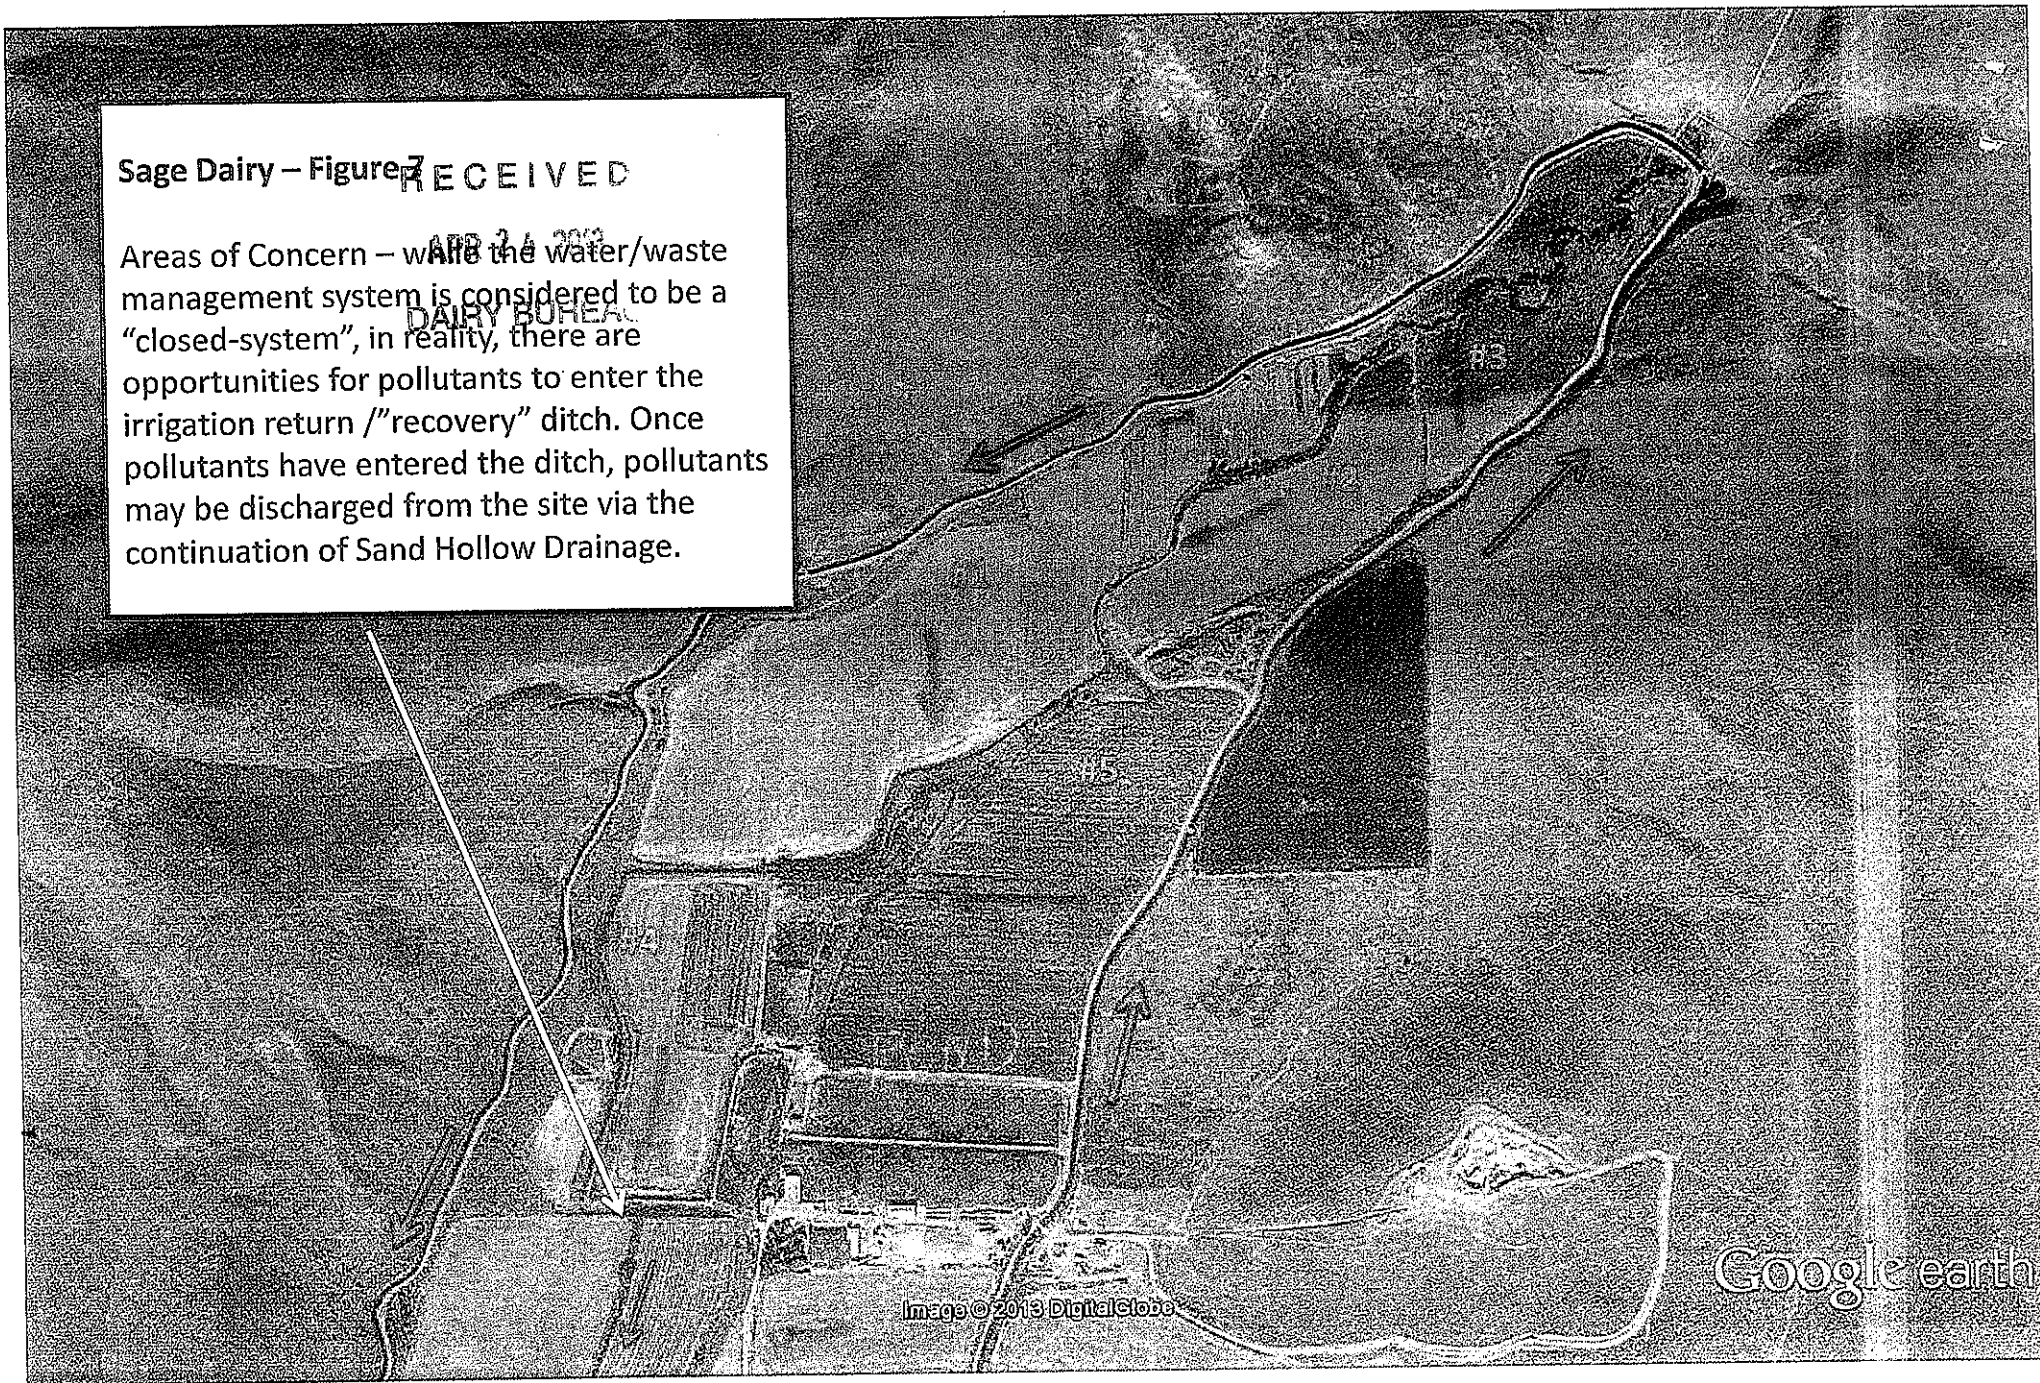
Sage Dairy – Figure 2

Waste management ponds and
"irrigation return/recovery ditch"

"Weeping Wall"; liquid
waste passes through here
to next pond

Secondary separation
pond

Primary waste
management pond
liquids and slurry
initially goes here

"Irrigation return ditch"; receives water from 3 sources:
direct flow from Sandy Hollow Drainage; surface irrigation return from
northern fields; and surface irrigation return from east-side field where liquid waste is applied

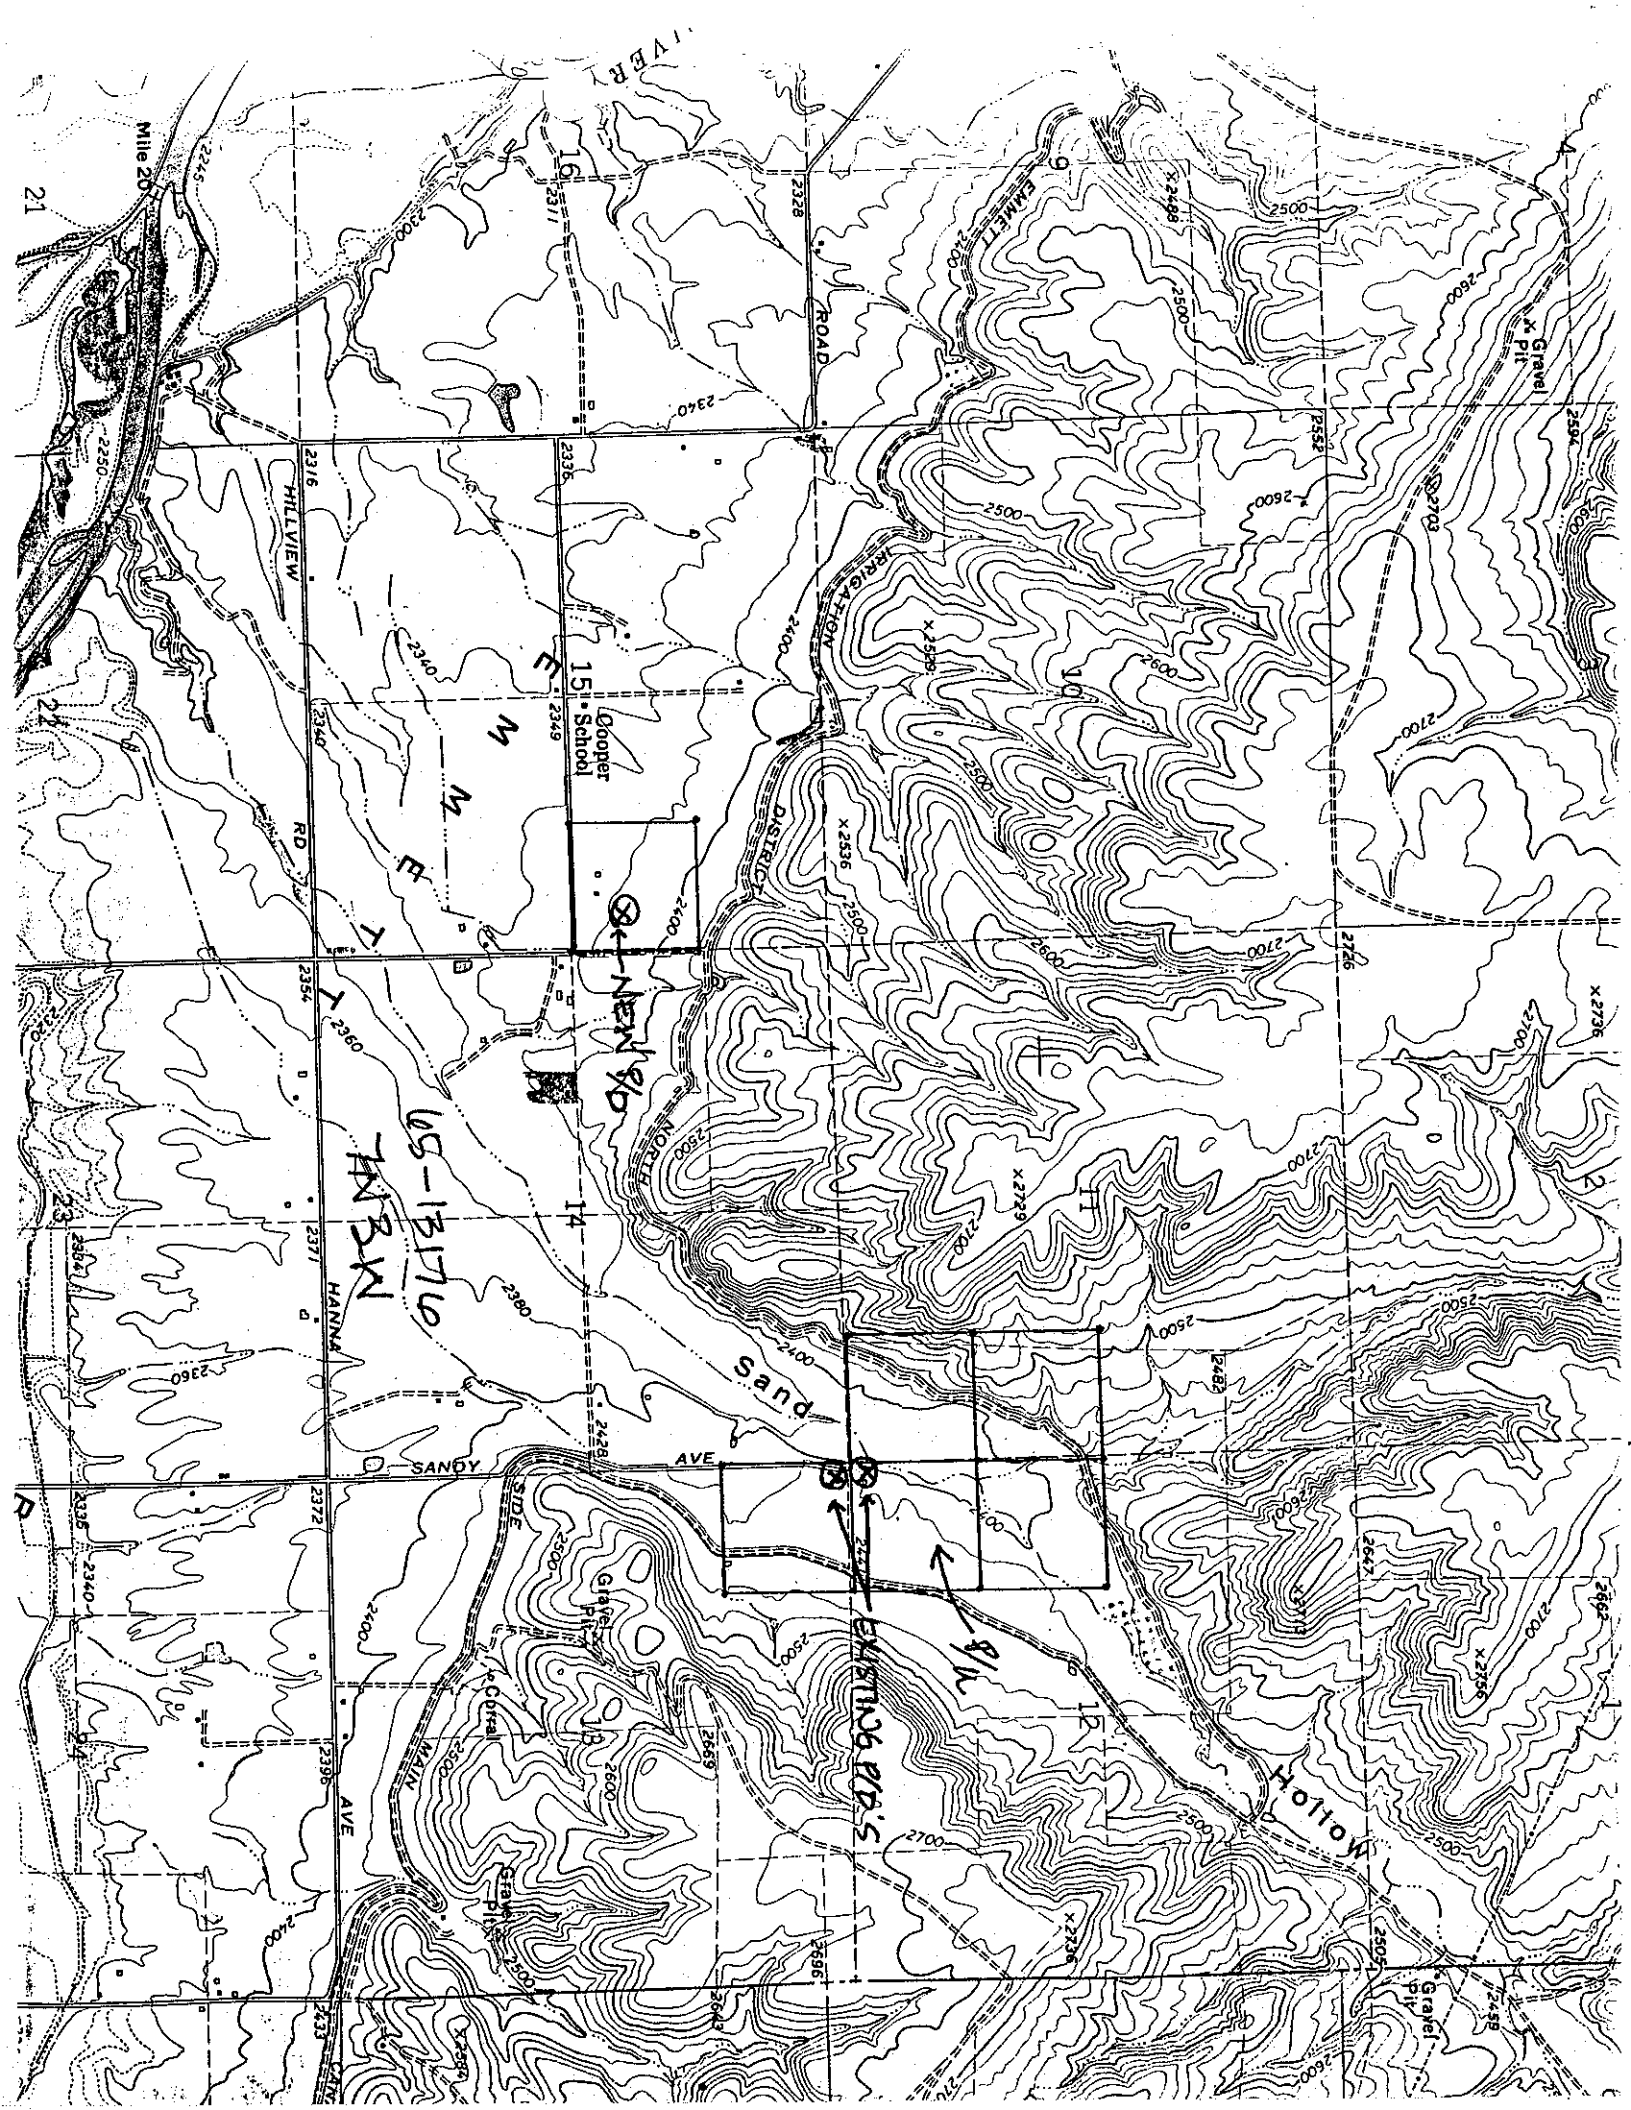
Sage Dairy – Figure 7

Areas of Concern – while the water/waste management system is considered to be a “closed-system”, in reality, there are opportunities for pollutants to enter the irrigation return / “recovery” ditch. Once pollutants have entered the ditch, pollutants may be discharged from the site via the continuation of Sand Hollow Drainage.
